MTL TR 88-6

METALLURGICAL EXAMINATION OF A DIAPHRAGM - LOCKUP CLUTCH PISTON

VICTOR K. CHAMPAGNE, Jr.

April 1988

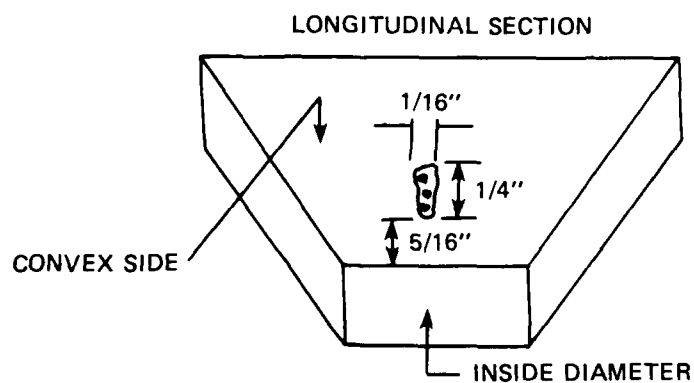
There was, however, one unusual feature observed while examining the microstructure of one diaphragm. Another type of structure was discovered outside the fracture region of one longitudinal section as illustrated in Figure 8. This structure was much coarser in appearance than the predominate tempered martensite and contained large white facets, as shown in Figure 9. The structure was located approximately 5/16" away from the edge of the inside diameter and was approximately 1/4" long and 1/16" wide. The region where the structure existed did not experience any cracking and was not in close proximity to any cracks. Microhardness measurements were taken within this area and are listed adjacent to Figure 8. The readings obtained did not differ from those measured of the surrounding microstructure listed in Table 3. An energy dispersive spectroscopy (EDS) analysis was performed within regions of the "coarser" microstructure to determine if it may have been formed as a result of a nonhomogeneous material. The test did not reveal any foreign elements or impurities. The structure could be a high temperature transformation product. There was no evidence found during this investigation that could relate the formation of the "coarser" microstructure to the cause of cracking.

Coarse Structure

<u>Knoop</u>	<u>HRC</u>
490	47
487	47
495	47

Figure 8. Illustrates the approximate location of the unusually etched area.

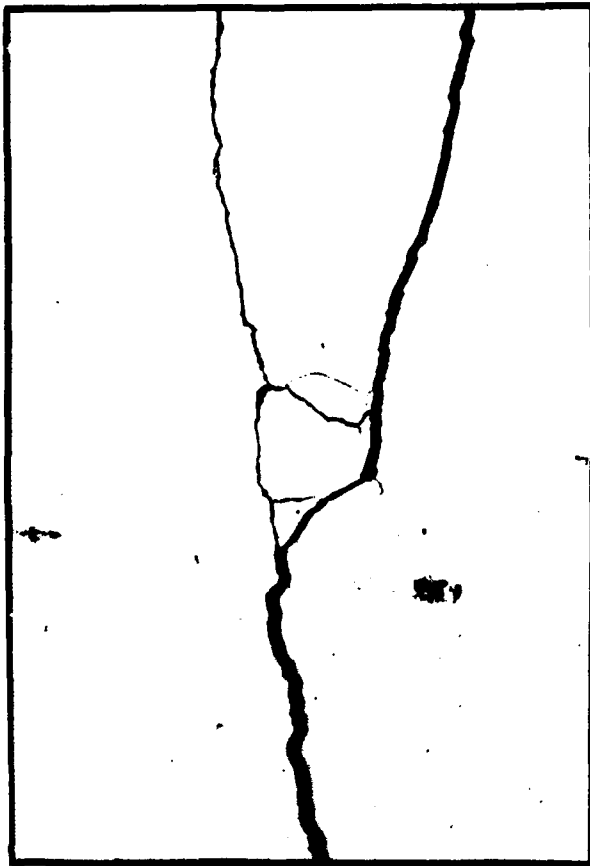
The cracks were examined under high magnification in order to identify any unusual features of the material or the fracture. Crack branching was observed in many instances. Figures 12 and 13 are as-polished longitudinal and transverse sections, respectively, which show examples of branching. In Figure 13 there appears to be evidence of some type of scale or oxide that has formed on the

Figure 12. Longitudinal section showing an example of crack branching, Mag. 500X.

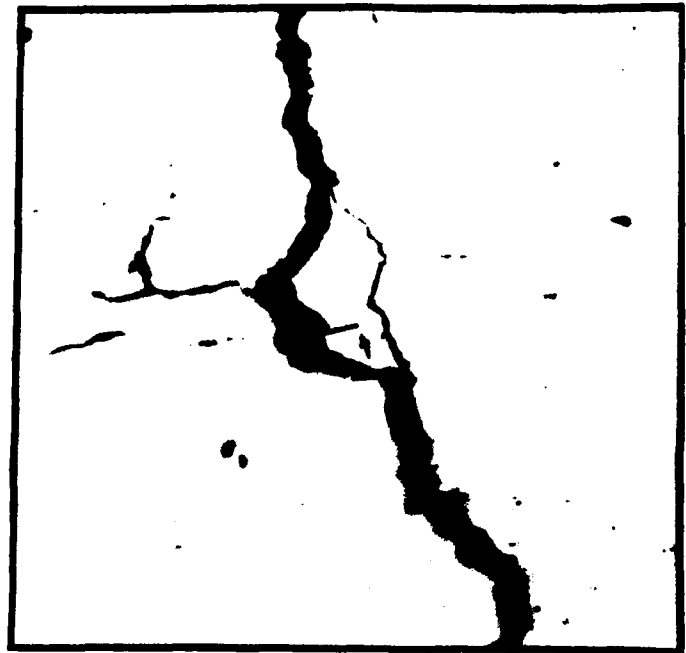
Figure 13. Transverse section revealing the presence of a surface film on the fracture surface, Mag. 1000X.

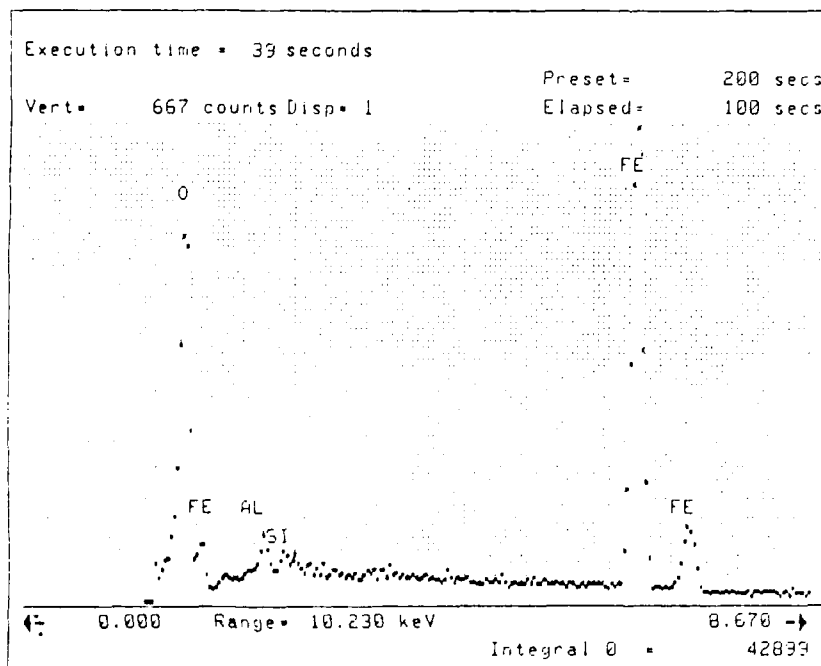
fracture surface. This was later confirmed by energy dispersive spectroscopy (EDS) when the fracture surface was investigated. Figure 14 shows the spectra obtained from the EDS analysis performed on one typical area from the fracture (see Figure 13 for exact location). As expected, it contained mainly Fe and O, and very small amounts of Al and Si. The Al could be the result of polishing or the base material may have been Al killed during primary processing.

Figure 14. EDS spectra of the area identified in Figure 13.

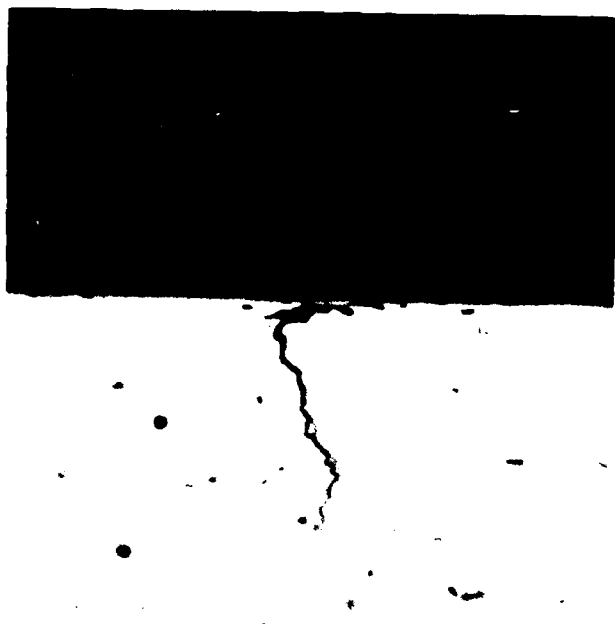
While examining the surfaces of cracked regions, it was found that cracking was sometimes associated with inclusions and other discontinuities in the material. Figure 15 reveals such an instance. Here a crack has originated at the surface irregularity. This small defect acted as a stress concentration area and when the stress parameters of the material were exceeded, a crack initiated here. Figure 16 shows the presence of inclusions over the entire surface of a longitudinal section. In many areas, cracks were found propagating through inclusions and in other instances cracks had originated at sites occupied by inclusions. Some of these were identified as manganese sulfide inclusions. Figure 17 illustrates representative results obtained from an EDS analysis performed on three different regions (see Figure 16 for exact locations).

Figure 15. Transverse section showing a crack that initiated at a surface irregularity, Mag. 1000X.

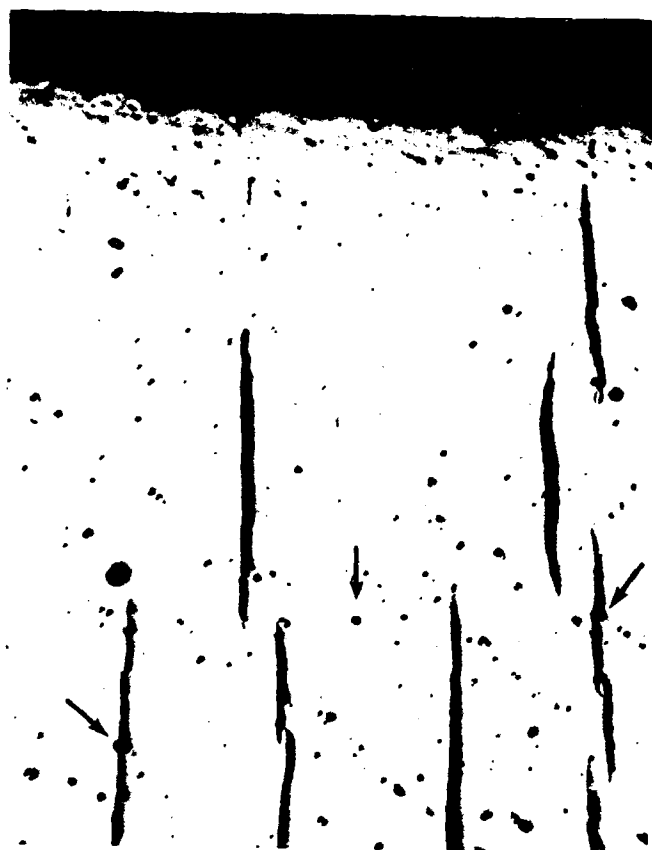
Figure 16. Longitudinal section reveals inclusions within the material, Mag. 500X.

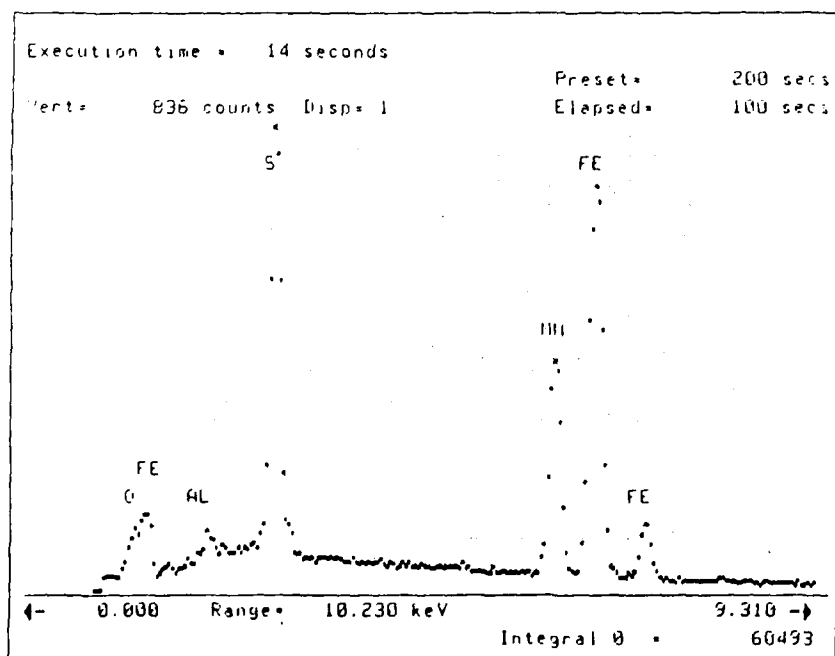
The typical spectra from these regions show large amounts of Fe, S, and Mn. Transverse fracture toughness and ductility can be decreased by these inclusions. Fatigue crack propagation characteristics of the material and corrosion resistance are also adversely effected.⁵ It was concluded that although these inclusions may have contributed in some instances to the cracking observed, they are not the primary cause, since many of the cracks examined were not associated to any extent with these inclusions and the material itself was not considered a "dirty steel."

Figure 17. Typical EDS spectra of the areas identified in Figure 16.

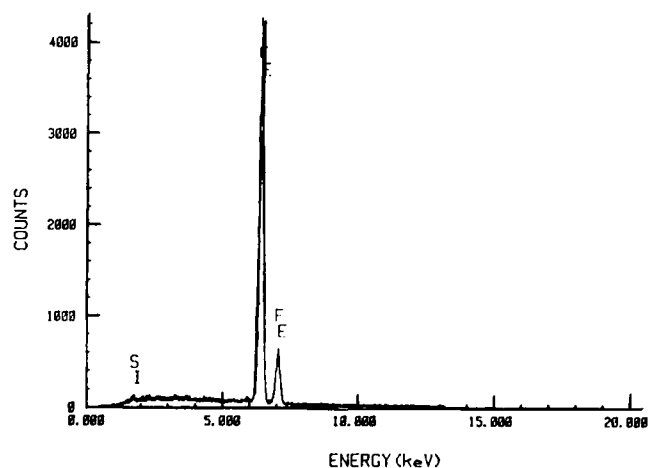
AREAS 1 & 2

The fracture surfaces of the cracks were examined by EDS. Figure 24 is an example of one fracture showing the areas which were investigated. Figure 25 shows representative results of the spectra obtained in areas 1 and 2 near the crack origin. Large amounts of Fe were detected, along with a trace of Si. There were no

Figure 25. Fractograph and corresponding EDS spectra representative of areas 1 and 2 of Figure 24, Mag. 500X.

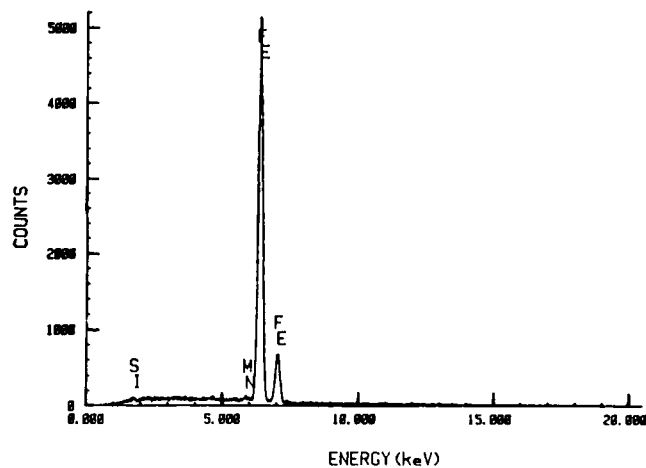
AREA 3

foreign elements, such as Cl present. The SEM fractograph of this area reveals the presence of a scale and debris. Figure 26 shows the spectra of area 3. The only difference discovered is the addition of a small amount of Mn. The laminated structures are quite visible in the SEM fractograph taken of this area. The fracture morphology in area 3 is clearly distinct because of the absence of a thick film or corrosion products.

Figure 26. Fractograph and corresponding EDS spectra representative of area 3 on Figure 24, Mag. 500X.
